# Water vole mitigation techniques

A questionnaire research project

No. 415 - English Nature Research Reports

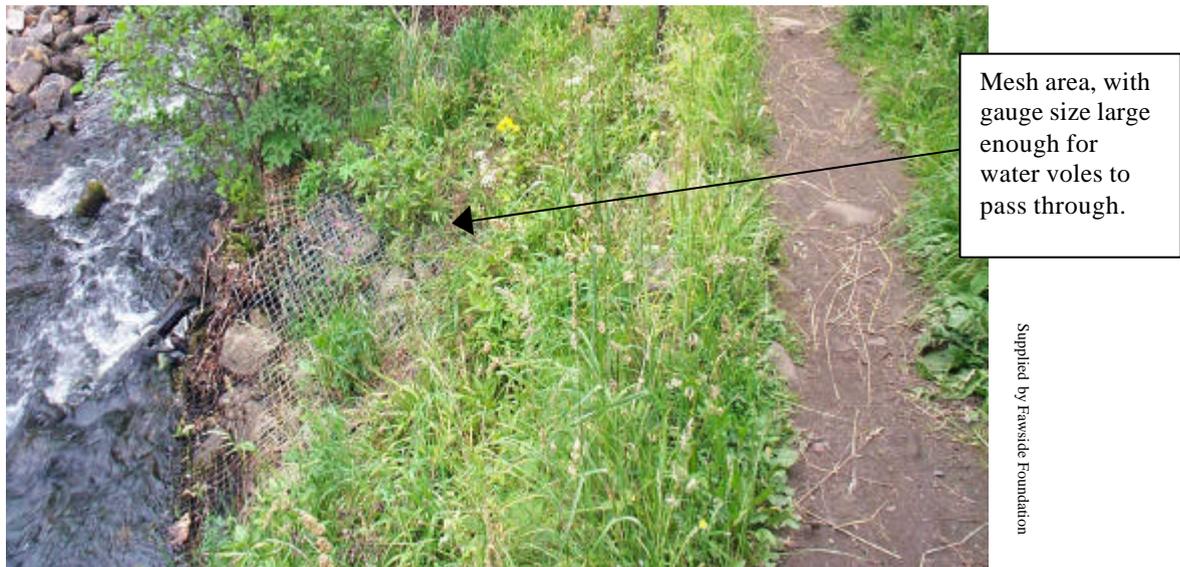
**Figure 3: Gabion mesh used to make small repairs**

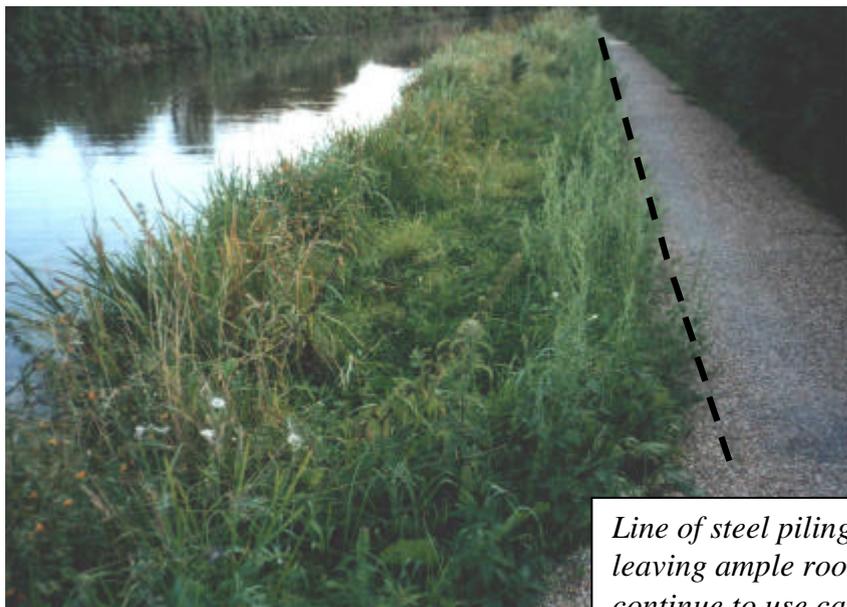
**Figure 6: Restored towpath with sheet piling under the towpath**

*Line of steel piling set under towpath, leaving ample room for water voles to continue to use canal banks*

In Oxfordshire, along Drinkwater's Embankment, Oxford Canal, British Waterways successfully buried sheet piling under the outer edge of the towpath instead of the bank edge. The end result was a protected canal bank with ample opportunity for water voles to return. They have now been recorded along the canal bank at this point in good numbers, representing a successful mitigation project.

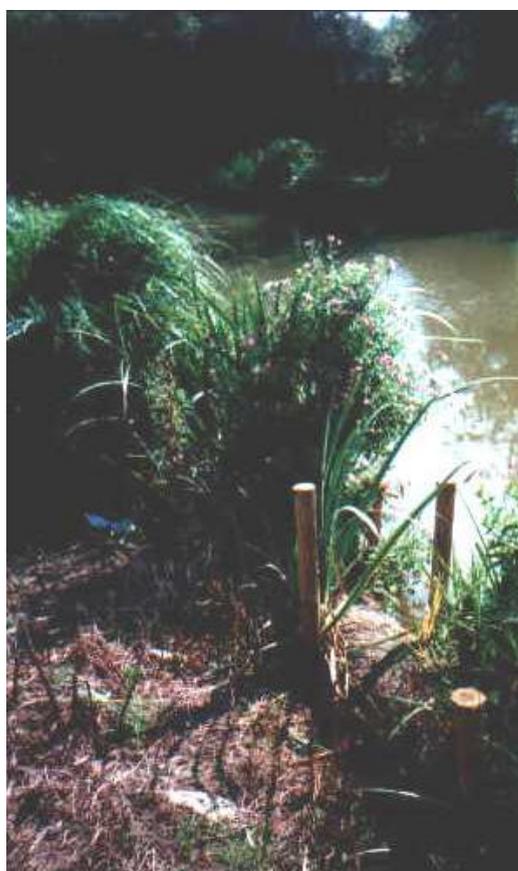
***Figure 7: Coir rolls pinned with willow poles, with no other bank revetment***

***Type 2: Concrete piling with coir rolls below (fig. 7)***

Where still intact, the old concrete canal piling was left untouched in some stretches and coir rolls were attached at water level. While some latrines were found (11.3/100m), and some feeding stations (17.0/100m), no burrows were located.

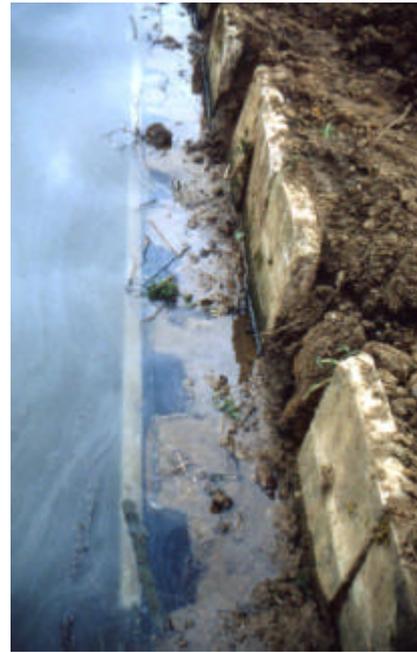
**Figure 8: Concrete piling with gaps to provide 'bays' of damp earth, steel piling to water level**

Stretches of bank were repaired using steel piling, where significant repairs were required to stop canal leakage. The deteriorating concrete piling was left in place, and steel piling was driven in to water level approx. 150 mm in front of the original piling. The 150 mm trench was back-filled to encourage colonisation by emergent vegetation and the original concrete was broken at intervals to provide 'bays' of damp earth. Some evidence of burrowing (2.0/100m), latrines (11.0/100m) and feeding (7.0/100m) was recorded.

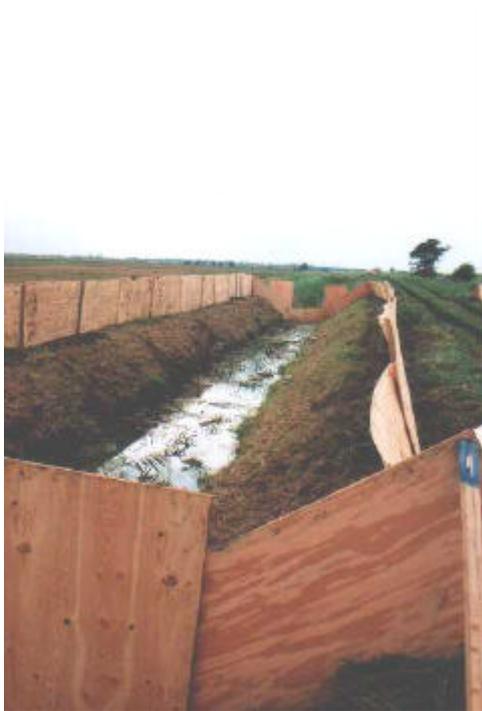
**Figure 11: Fencing of strimmed area**

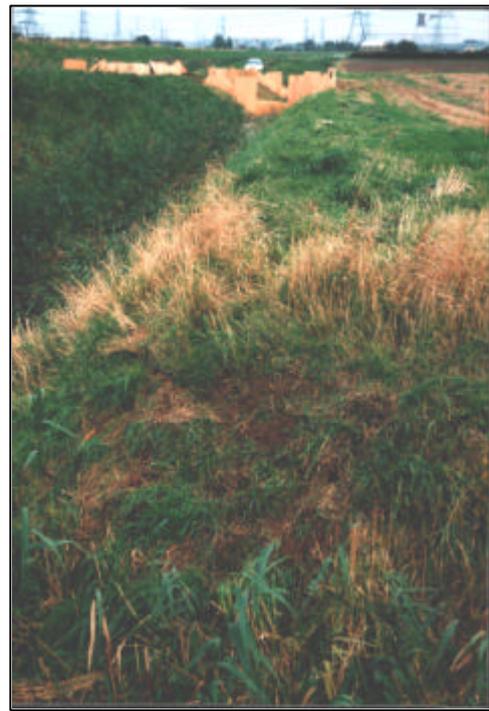
New burrow system 100 metres from original site.

**Figure 12: Newly created burrow system**

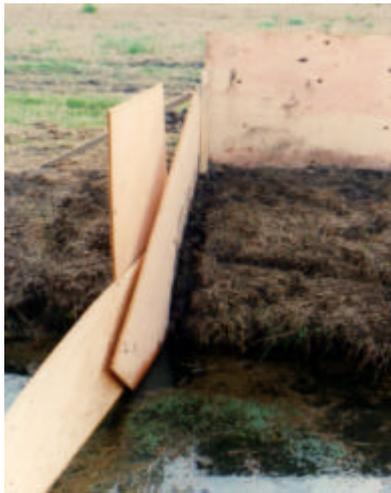
*Figure 14: Plywood dug into the banks to cut off inter-connecting burrows prior to trapping.*

- Fencing down a bankface should ensure that connecting burrows are cut off from the outside by the fencing being buried deep enough (fig. 14). At Keadby in Lincolnshire (see 5.4.1), a JCB was employed, with a spike-ripper, to tear a slot into the ground down to water level, into which fencing was buried. An ecologist was on-site to carefully observe operations, and the JCB was kept off the bank top to avoid causing any underground burrows to collapse

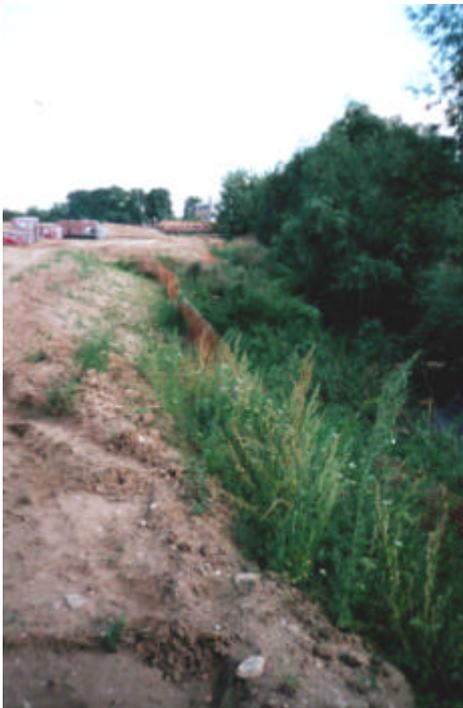
A development project in Oxfordshire left the adjacent watercourse habitat protected from direct impact, with a buffer zone of 2 – 3 metres (fig. 15). The habitat was ideal for water voles and was occupied prior to development works commencing. Subsequent survey work in August, once the works were underway, found no water voles present. Clearly, as can be seen from the adjacent picture, the development caused significant disturbance for a prolonged period. However, the water voles did have alternative habitat to occupy up- and downstream and chose to move of their own accord.

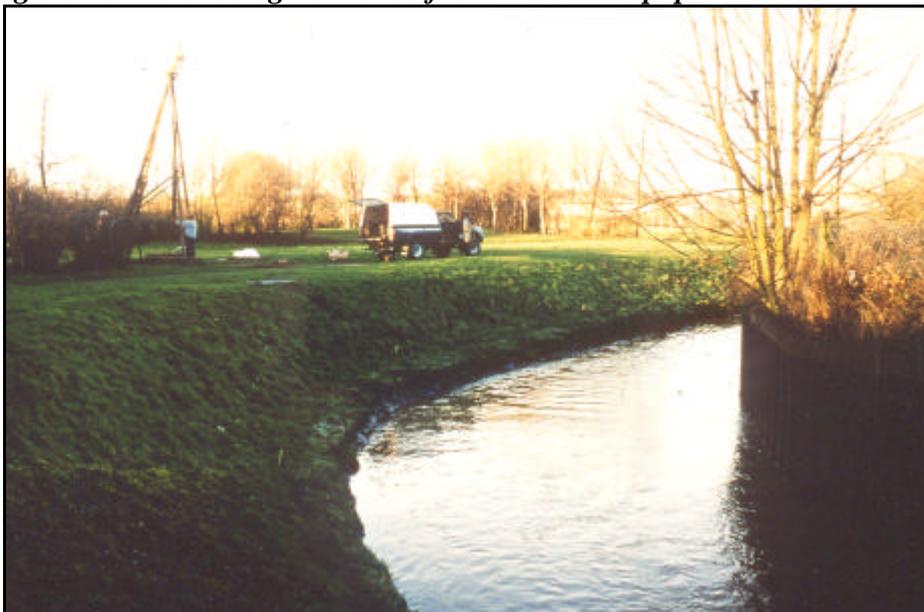
***Figure 16: Boreholing 10 metres from water vole population***

One project in the East Midlands required percussion bore-holing within 10 metres of occupied banks, lasting for 5 hours (fig. 16). The population was monitored both visually and through photographic monitoring of the vegetation to record any significant changes in trampling (by voles migrating through the night). The disturbance was so great that the percussion bore-holing caused the opposite banks from the bore-holing to noticeably vibrate and no other form of bore-holing was feasible at this site.

No evidence of water voles leaving the site was recorded, and fresh latrines were found throughout the site. The water voles clearly remained *in situ*, and tolerated the disturbance. There is no information from this or other projects to assess whether water voles would move should the disturbance have lasted longer. Therefore, it is reasonable to require bore-holing to be staged when it is likely to last more than one day. Perhaps one or two day lapses would be suitable.

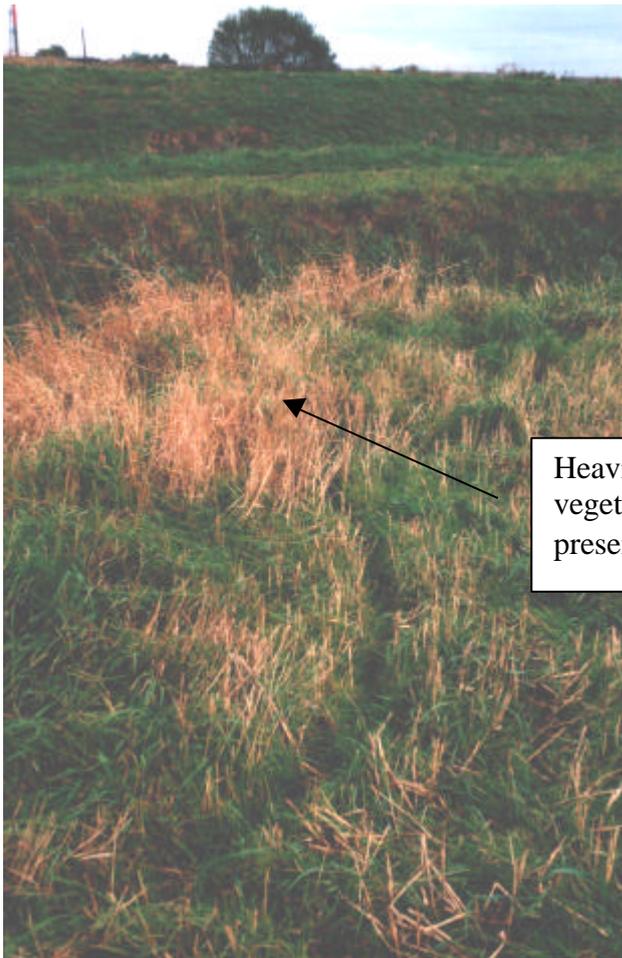
**Figure 17: Trampled runs left by excluded water voles overnight**

Heavily trampled run in vegetation that was not present prior to exclusion

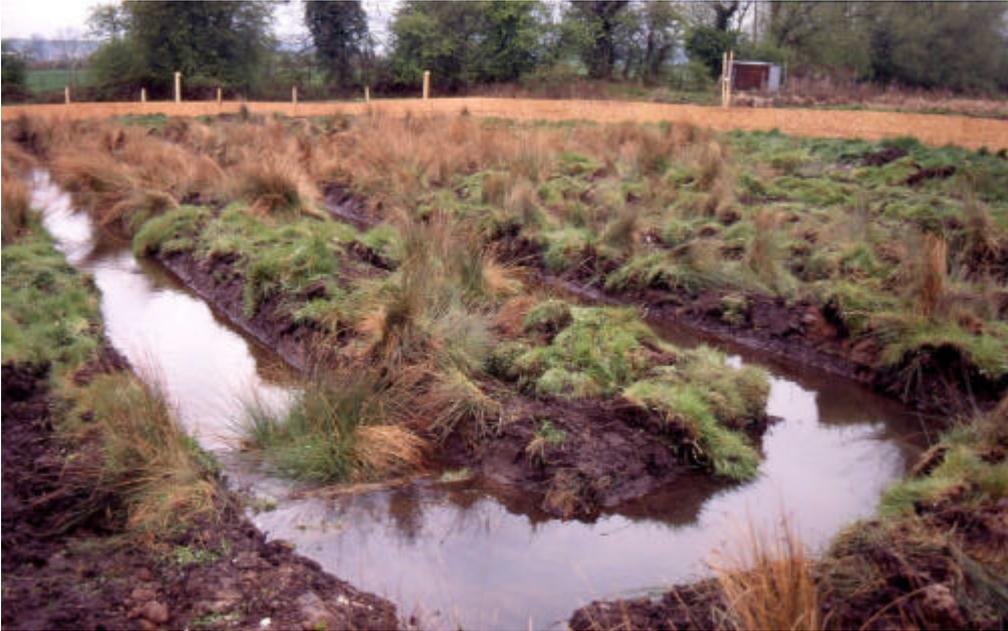
*Figure 18: Newly created water vole habitat, River Leen*

The site was constructed by carefully digging a single ditch that zig-zagged back and forth to create the maximum length of watercourse possible in the available area. The ditch was cut using a long reach excavator to avoid damaging the vegetation on either side of the new channel. The vegetation along the line of the ditch itself was carefully stripped off as a series of turves and these were carefully placed along the finished channel so that they overhung the sides. The upstream end of the ditch was linked to the River Leen by a pipe to provide an inflow of water to the site and a piped outlet was installed at the bottom end. Water levels within the arms of the ditches were adjusted by placing spare turves in the channel to create mini dams.

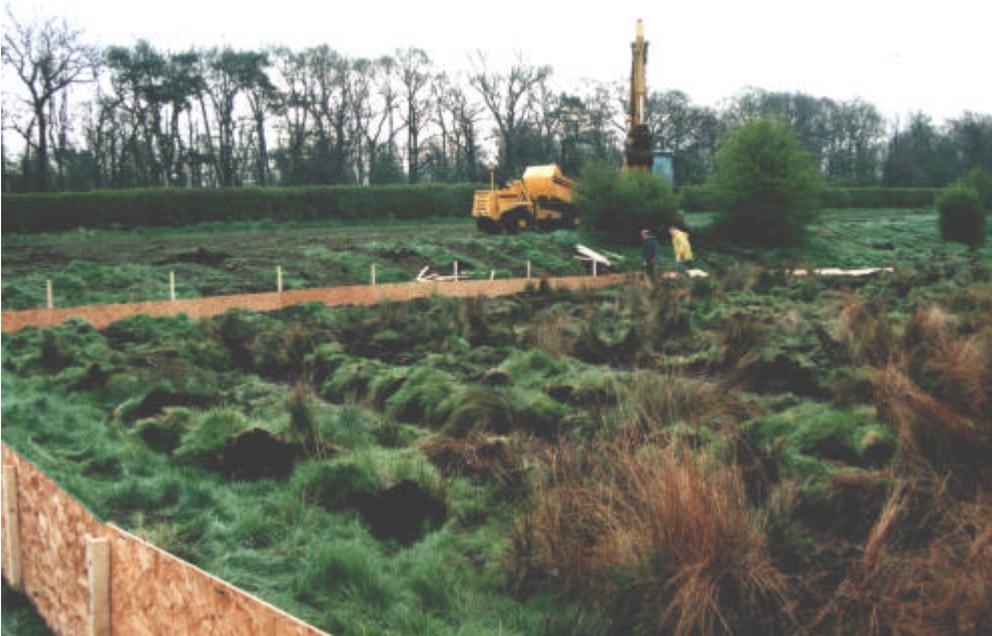
*Figure 19: Water vole fencing*

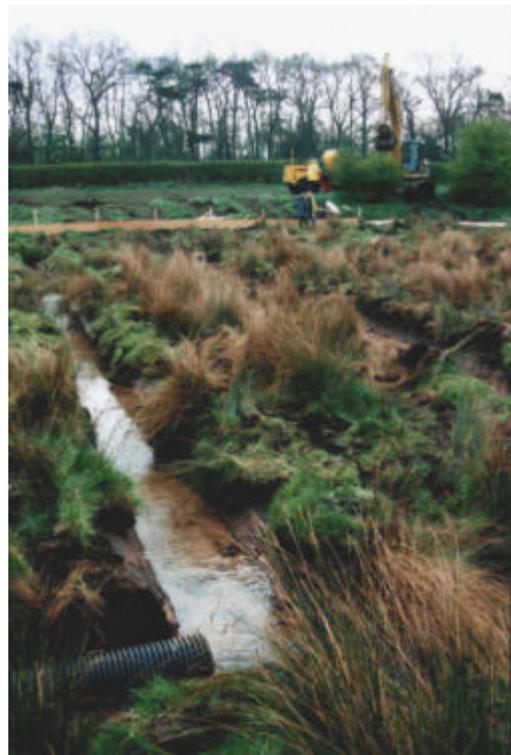
**Figure 20: Pipe inlet from the neighbouring river to provide a constant water supply**
